Ferro Vazquez, Maria De La Cruz, Lang, Carol orcid.org/0000-0002-0437-5585, Kaal, Joeri et al. (1 more author) (2017) When is a terrace not a terrace? The importance of understanding landscape evolution in studies of terraced agriculture. *Journal of Environmental Management*. pp. 500-513. ISSN 0301-4797

When is a terrace not a terrace? The importance of understanding landscape evolution in studies of terraced agriculture

*C. Ferro-Vázquez¹; C. Lang¹; J. Kaal^{2,3} and D. Stump¹

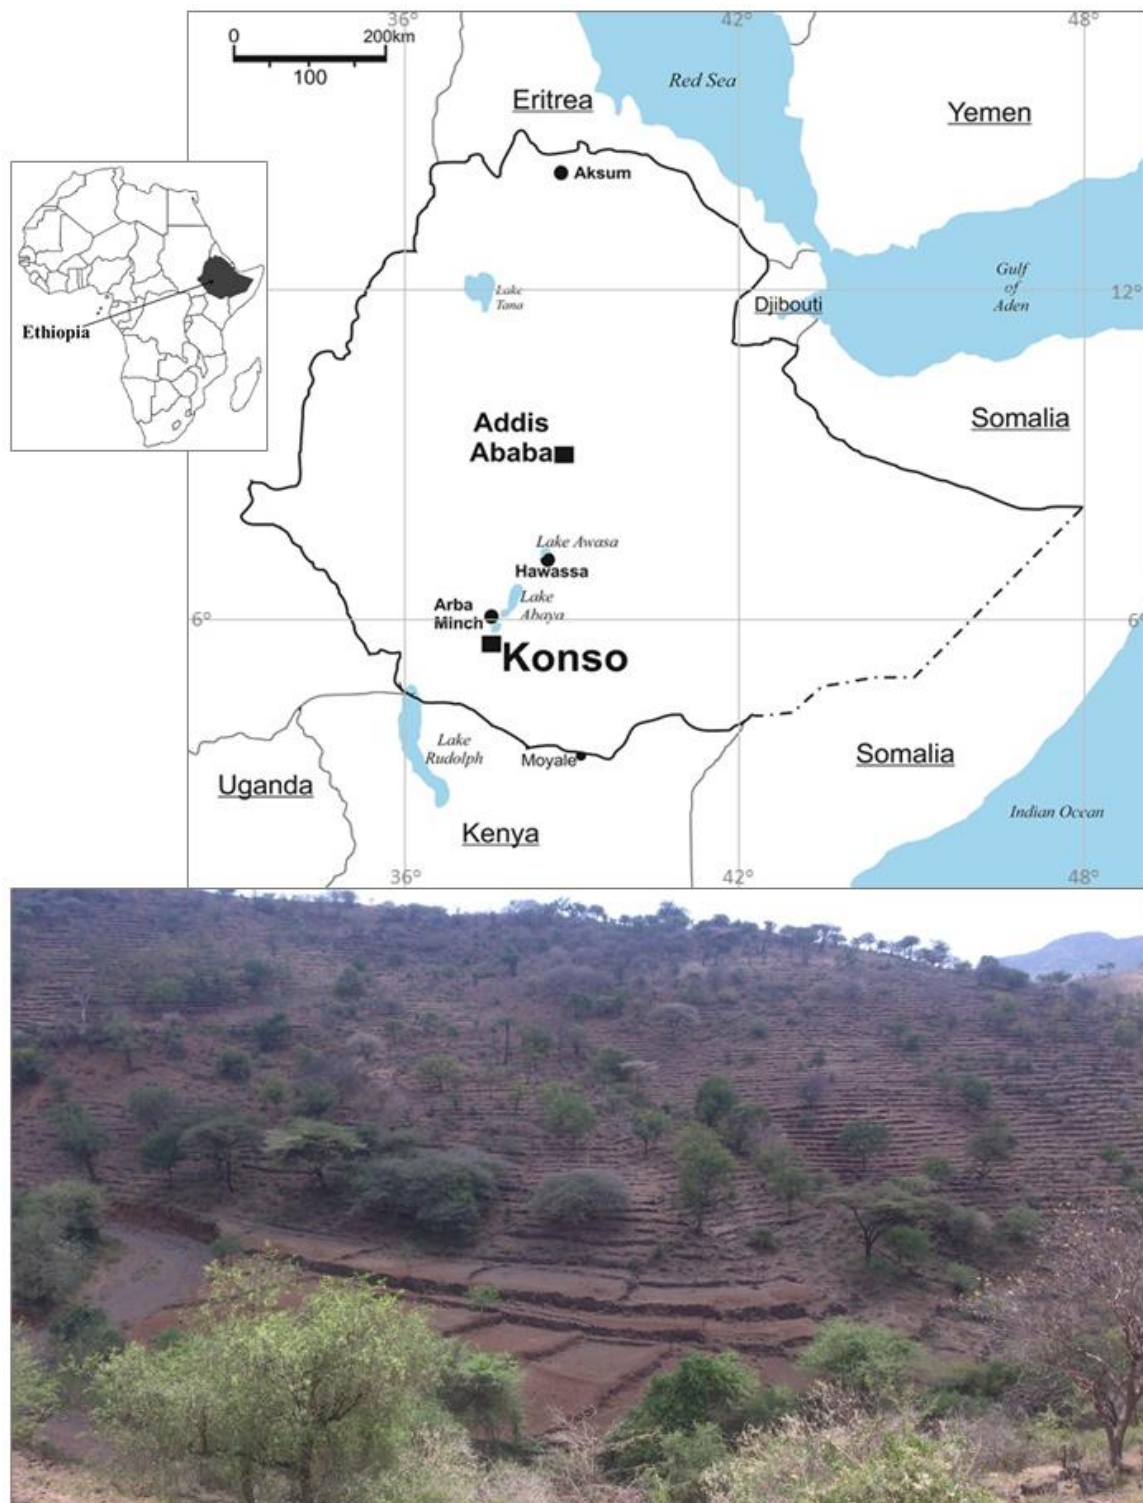
Figure 1. Above: location of Konso in relation to the administrative centre for the region (Hawassa). Below: hillside terraces (background) and yela sediment traps (foreground) in the Sahayto area, located in the northeast of the Konso highlands.

The work reported upon here focused on terraces located on a west-facing hill slope above the Kilkilo river basin in the Sahayto area (Figure 1), with this area chosen for three reasons. Firstly, because the northeastern corner of Konso contains the highest concentration of historic walled towns, is said by some oral traditions to be the historic heartland of the Konso settlement, and is the area consistently described by visitors from the 1950s onwards as containing the densest and best maintained terraces. Secondly, the area contains both terraces that are currently cultivated and examples that are said to have remained uncultivated for 10 years or more. Finally, the area includes both hillside terraces and riverside sediment traps, in many places with these two types of fields physically abutting one another.
